Manhole Inspection Summary

Manhole # S21KK_033MH

Insp Date: **5/31/07 11:22 AM**

Location Address: **2036 FULTON AVE**

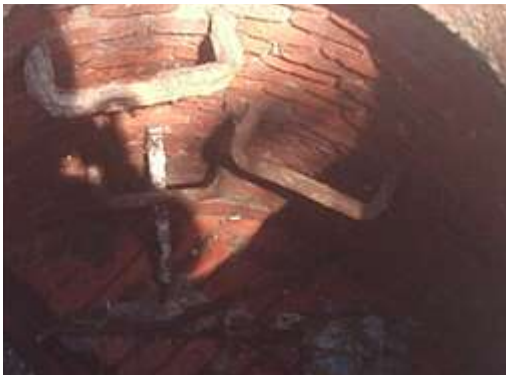
Defect 2

Steps Count: **3** Missing: **0** ☒ **Corroded**

CORRODED STEPS

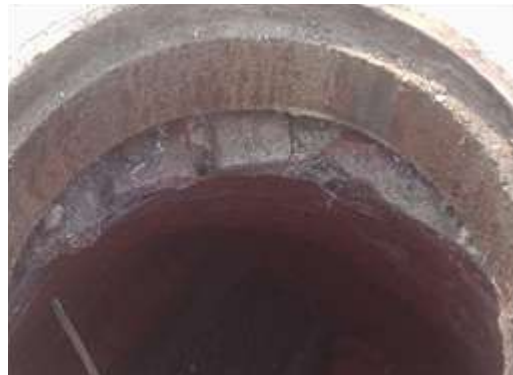
Defect 1

Frame Offset: **2** (in.) Condition: ☒ Sound ☐ Cracked ☐ Leaks

Condition: ☐ Sound ☐ Cracked ☐ Root Intrusion ☒ **Loose Brick** ☐ Deteriorated

FRAME OFFSET AND LOOSE
CHIMNEY BRICKS AT CHIMNEY

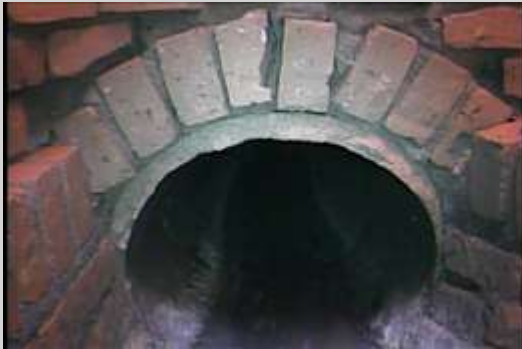
12 O'Clock Outflow

15 in. Circular Gravity Sewer
Pipe Out @ 12 O'Clock

Pipe Height: **14.4** (in.) Rod and Bar (Angled)
Pipe Material: **Clay** ☐ Pipe Lined
Invert Depth: **7.59** (ft.) Flow Characteristics: **Slow**
Deposits: ☒ None ☐ Mud ☐ Sludge ☐ Debris ☐ Grease
Silt Depth: (in.) Deposits Extent:
Infiltration: **None** Pipe Seal Cond: **Sound**

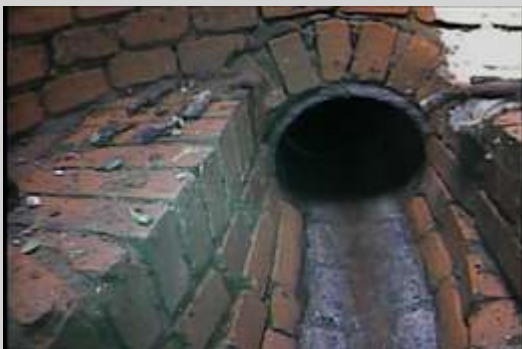
3 O'Clock Inflow

10 in. Circular Gravity Sewer
Pipe In @ 3 O'Clock

Pipe Height: **10.8** (in.) Rod and Bar (Angled)
Pipe Material: **Clay** ☐ Pipe Lined
Invert Depth: **7.11** (ft.) Flow Characteristics: **Slow**
Deposits: ☒ None ☐ Mud ☐ Sludge ☐ Debris ☐ Grease
Silt Depth: (in.) Deposits Extent:
Infiltration: **None** Pipe Seal Cond: **Sound**

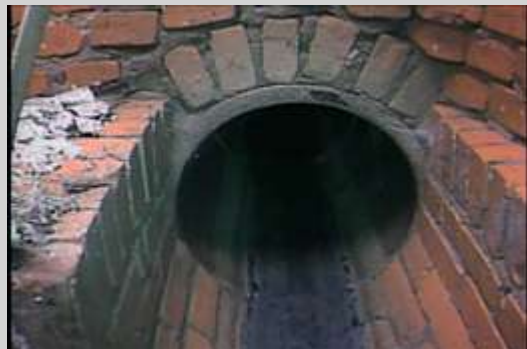
6 O'Clock Inflow

15 in. Circular Gravity Sewer
Pipe In @ 6 O'Clock

Pipe Height: **15.6** (in.) Rod and Bar (Angled)

Infiltration: **None** Pipe Seal Cond: **Sound**
